# X310 Device Discovery Issues

AN-620

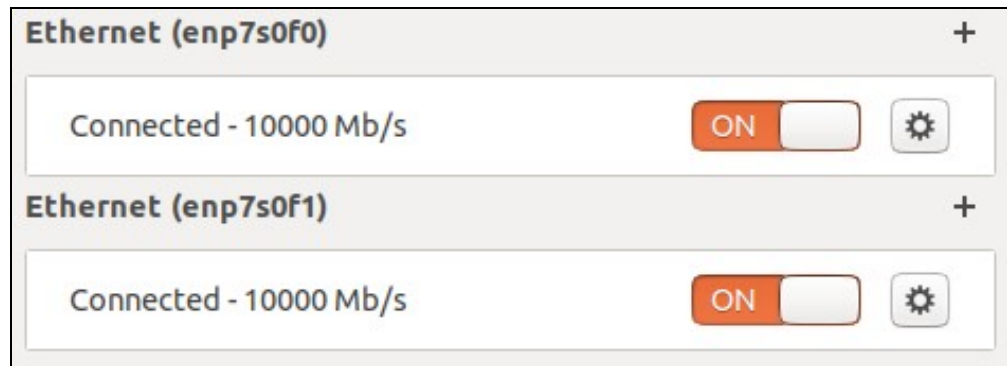
- ◆ Ensure your USRP is powered on.
- ◆ Ensure the SFP+ cable is plugged into port 1 of the USRP. This is a 10 Gig interface on both the HG and XG images.
- ◆ If your host machine is using a PCIe adapter for SFP+ interfaces, ensure it was enumerated correctly by your operating system. You may need to reinstall drivers or try a different PCIe port.
- ◆ Check that the SFP+ interface on your host machine is configured to support a 10 Gigabit link. If your NIC supports dual 10 GbE links, you can put it in loopback with your SFP+ cable and confirm that both ports recognize a 10GbE connection:

Figure 3: Ubuntu 18.04 Network Manager with 2 10GbE interfaces in loopback
