# X310 Device Discovery Issues

## AN-620

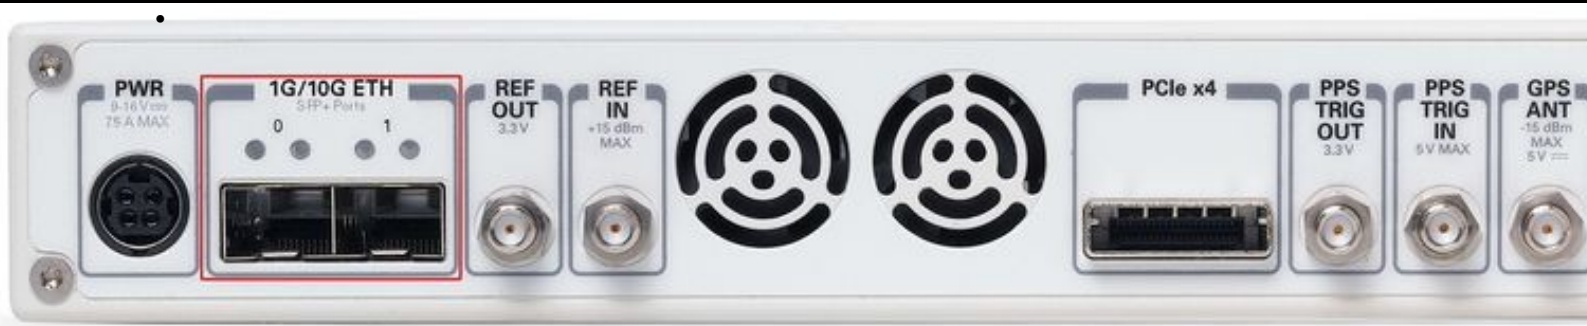
The X310 has a pair of SFP+ ports located on the rear panel of the device near the power input. These interfaces are labeled 0 and 1:

Figure 1: X310 Rear Panel with SFP+ ports emphasized.

It is possible to connect to the X310 over 1 Gigabit Ethernet via an SFP+ to RJ45 adapter or a 10 Gigabit Ethernet capable SFP+ cable. Whether or not your X3xx device is capable of using 1GbE is dependent on the FPGA image being used. With the HG image port 0 is 1GbE and port 1 is 10GbE. Using the XG image enabled dual 10GbE links (ports 0 and 1). See the [UHD Manual](#) for instructions regarding updating the FPGA image of your device.

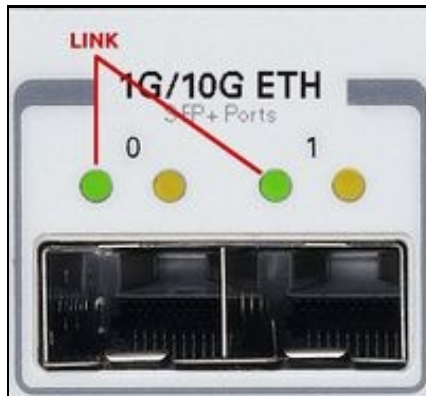
This protocol is supported only on X3xx SFP+ port 0 when using the HG FPGA image and a compatible SFP+ to RJ45 adapter. If both of these conditions are met, you will see the green LINK LED illuminate when a working SFP+ adapter is inserted into the powered-on X310. On X3xx devices, this LED should light up regardless of successful connection to host when a working SFP+ adapter is inserted.

Figure 2: X310 SFP+ ports with link and data LEDs.

- ♦ Ensure your USRP is powered on.
- ♦ If the green LINK LED does not illuminate in port 0, you should try a different (known working) SFP+ adapter.
- ♦ If a known good SFP+ adapter does not elicit a green LINK LED, you should attempt recovery using the HG image. See [X300/X310 Device Recovery](#).
- ♦ If this device recovery doesn't complete successfully or recovery doesn't bring back the link LED, contact Ettus Support.

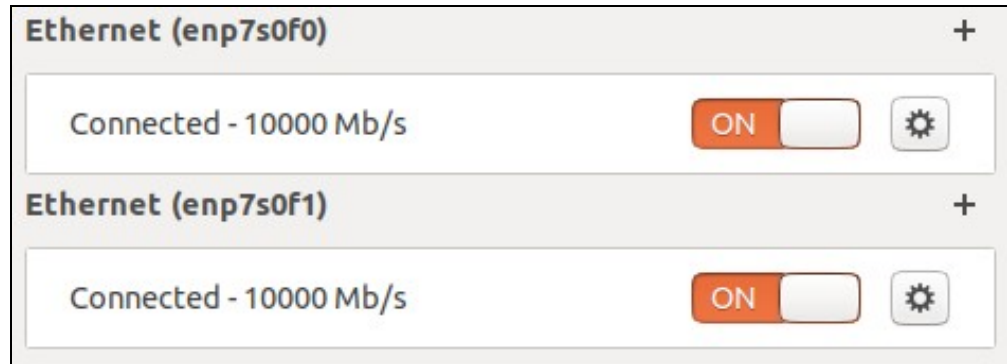
- ◆ Ensure your USRP is powered on.
- ◆ Ensure the SFP+ cable is plugged into port 1 of the USRP. This is a 10 Gig interface on both the HG and XG images.
- ◆ If your host machine is using a PCIe adapter for SFP+ interfaces, ensure it was enumerated correctly by your operating system. You may need to reinstall drivers or try a different PCIe port.
- ◆ Check that the SFP+ interface on your host machine is configured to support a 10 Gigabit link. If your NIC supports dual 10 GbE links, you can put it in loopback with your SFP+ cable and confirm that both ports recognize a 10GbE connection:

Figure 3: Ubuntu 18.04 Network Manager with 2 10GbE interfaces in loopback

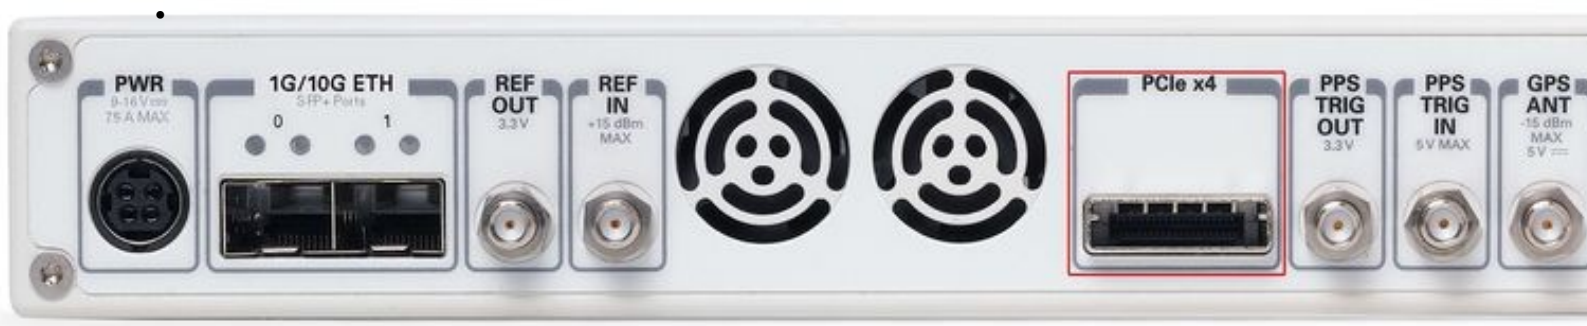
The X310 has a PCIe x4 located on the rear panel of the device near the power input. This interface is labeled PCIe x4 (also referred to as a MXI connection when used with a PXI system)

Figure 5: X310 Rear Panel with PCIe port emphasized.

It is possible to connect an X310 directly to a PC using an appropriate PCIe x4 link cable. It is necessary to install the [NI RIO Kernel Modules](#) to use this protocol on a system using UHD. On a Windows system using the [NI-USRP driver](#), the NI-USRP installation will eliminate the need to install NI-RIO Kernel Modules. The first step in establishing connectivity is starting the NI RIO Kernel Module drivers on your machine with:
