When a USRP B-series device is plugged into a USB port and powers up, both the firmware and FPGA images need to be loaded for it to work with UHD. These binaries will be loaded when UHD is started and pointed to the B-series USRP, regardless of the application, host computer, or OS.

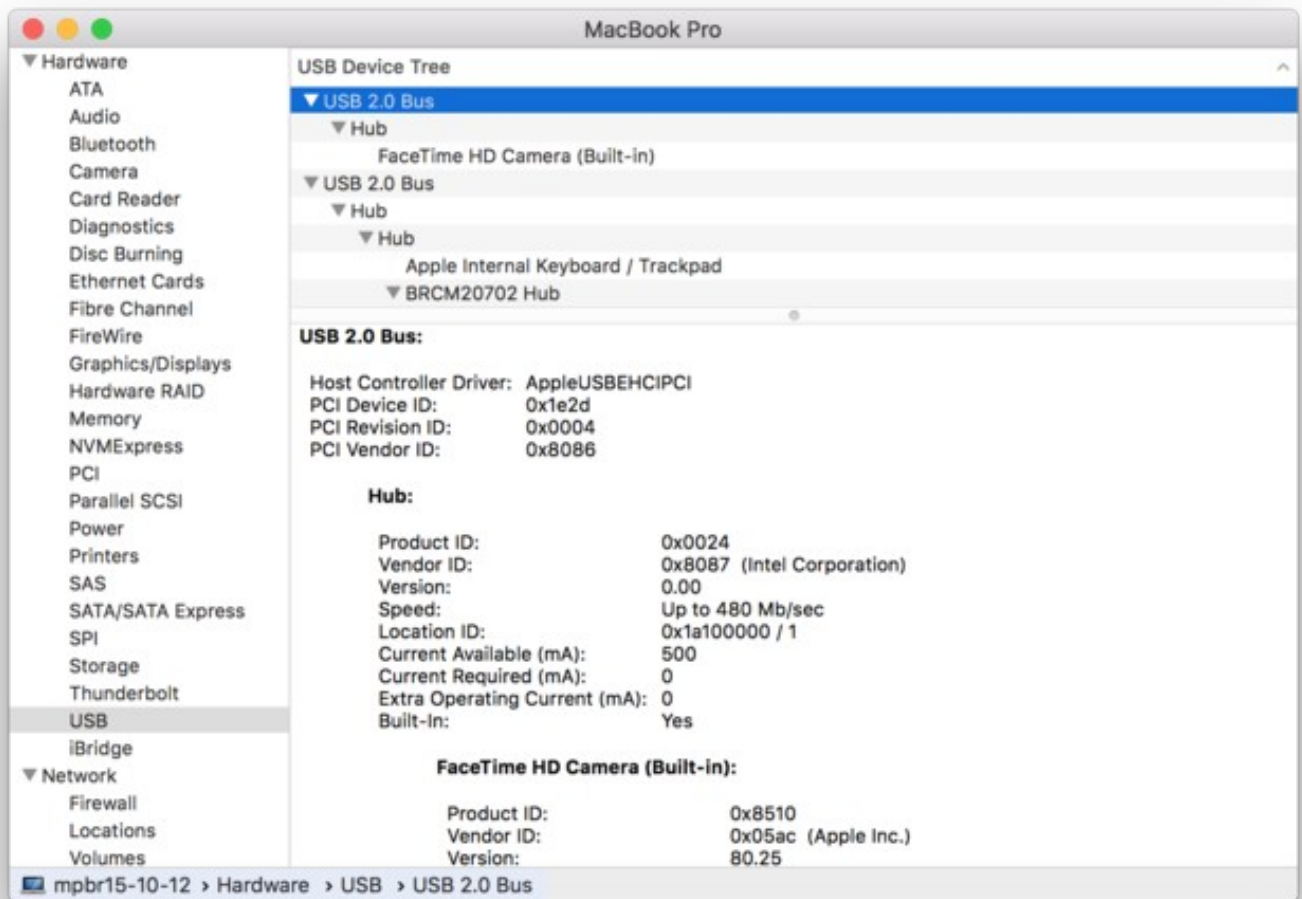
Clicking on the USB option shows the USB device tree in the upper pane and information for the first instantiated bus in the lower pane.

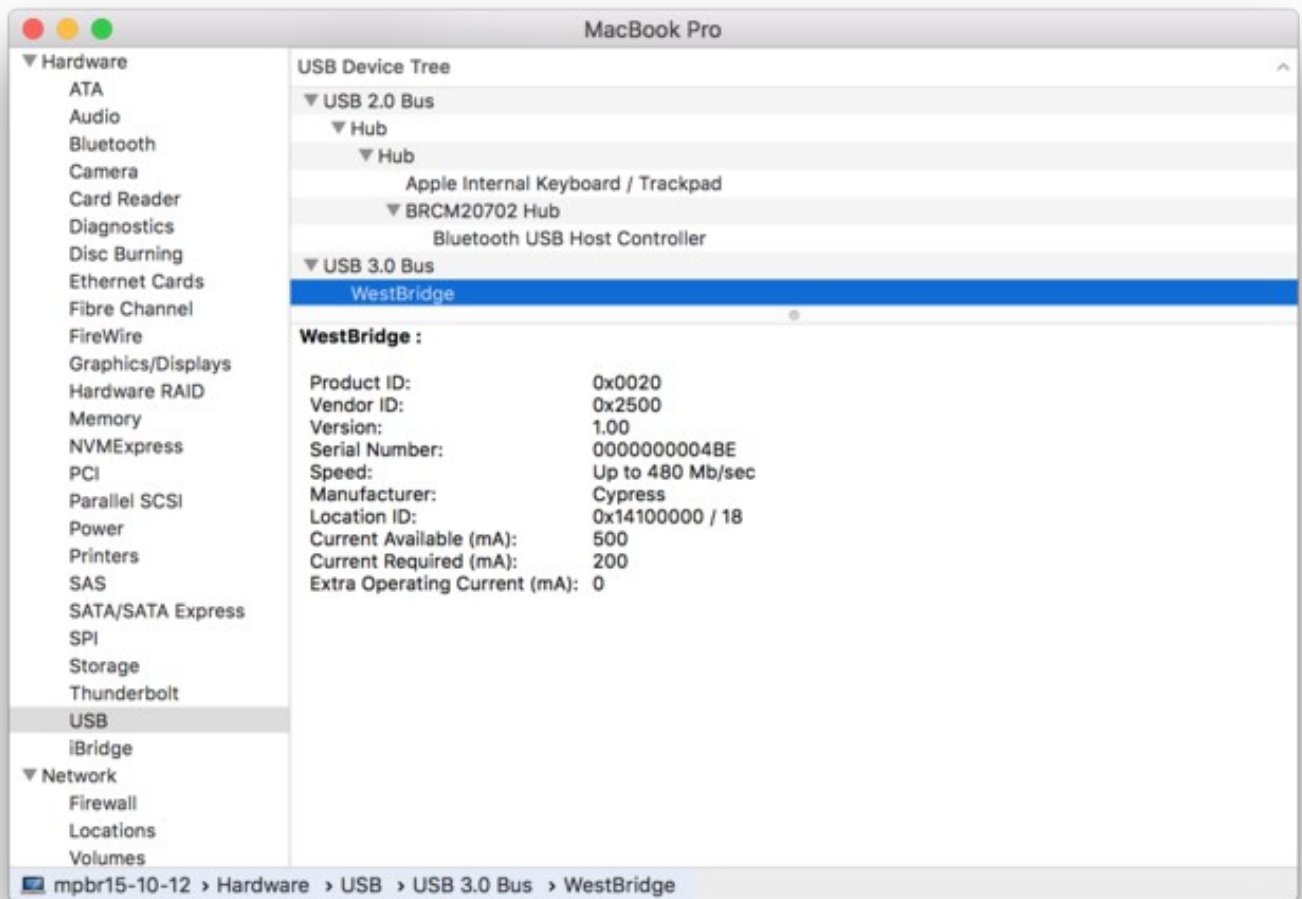
In the upper pane, scroll down until you find an entry for either *Westbridge* or *USRP B2**. The following screenshot shows the hardware information of a *USRP B210* immediately after it is plugged in and powered up.

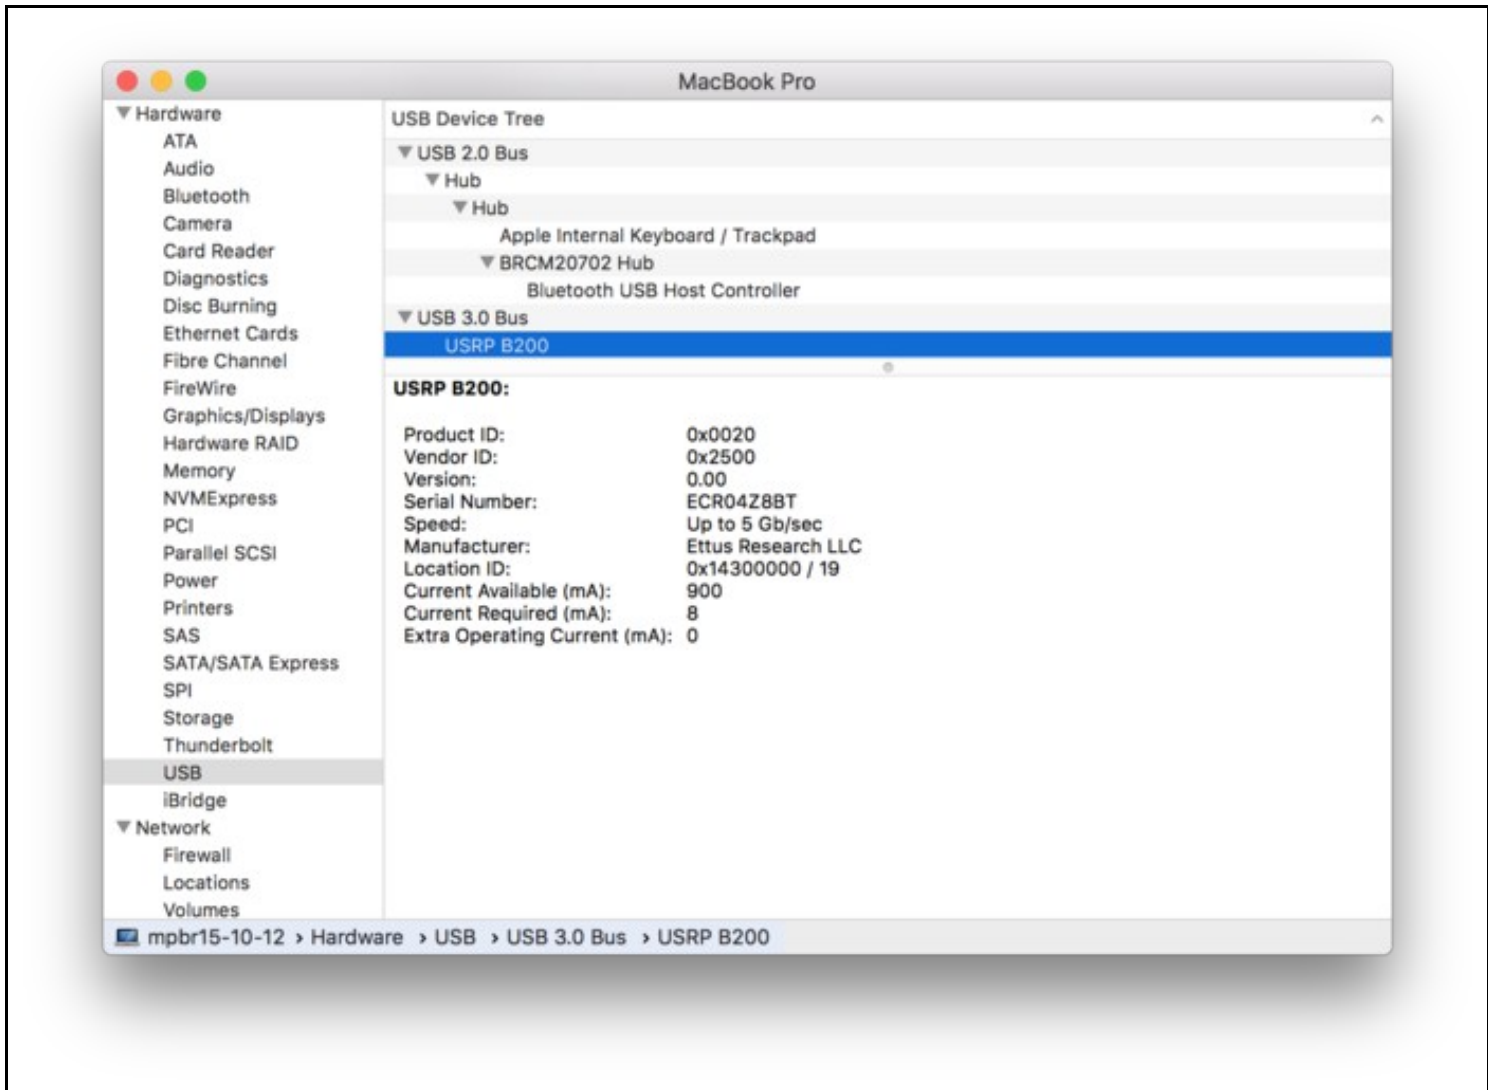
Once the USRP firmware is loaded -- more on this in the next section -- the device with "morph" on the bus, which will change the device name and capabilities. The following screenshot shows the hardware information of a USRP B210 after the firmware was successfully loaded.

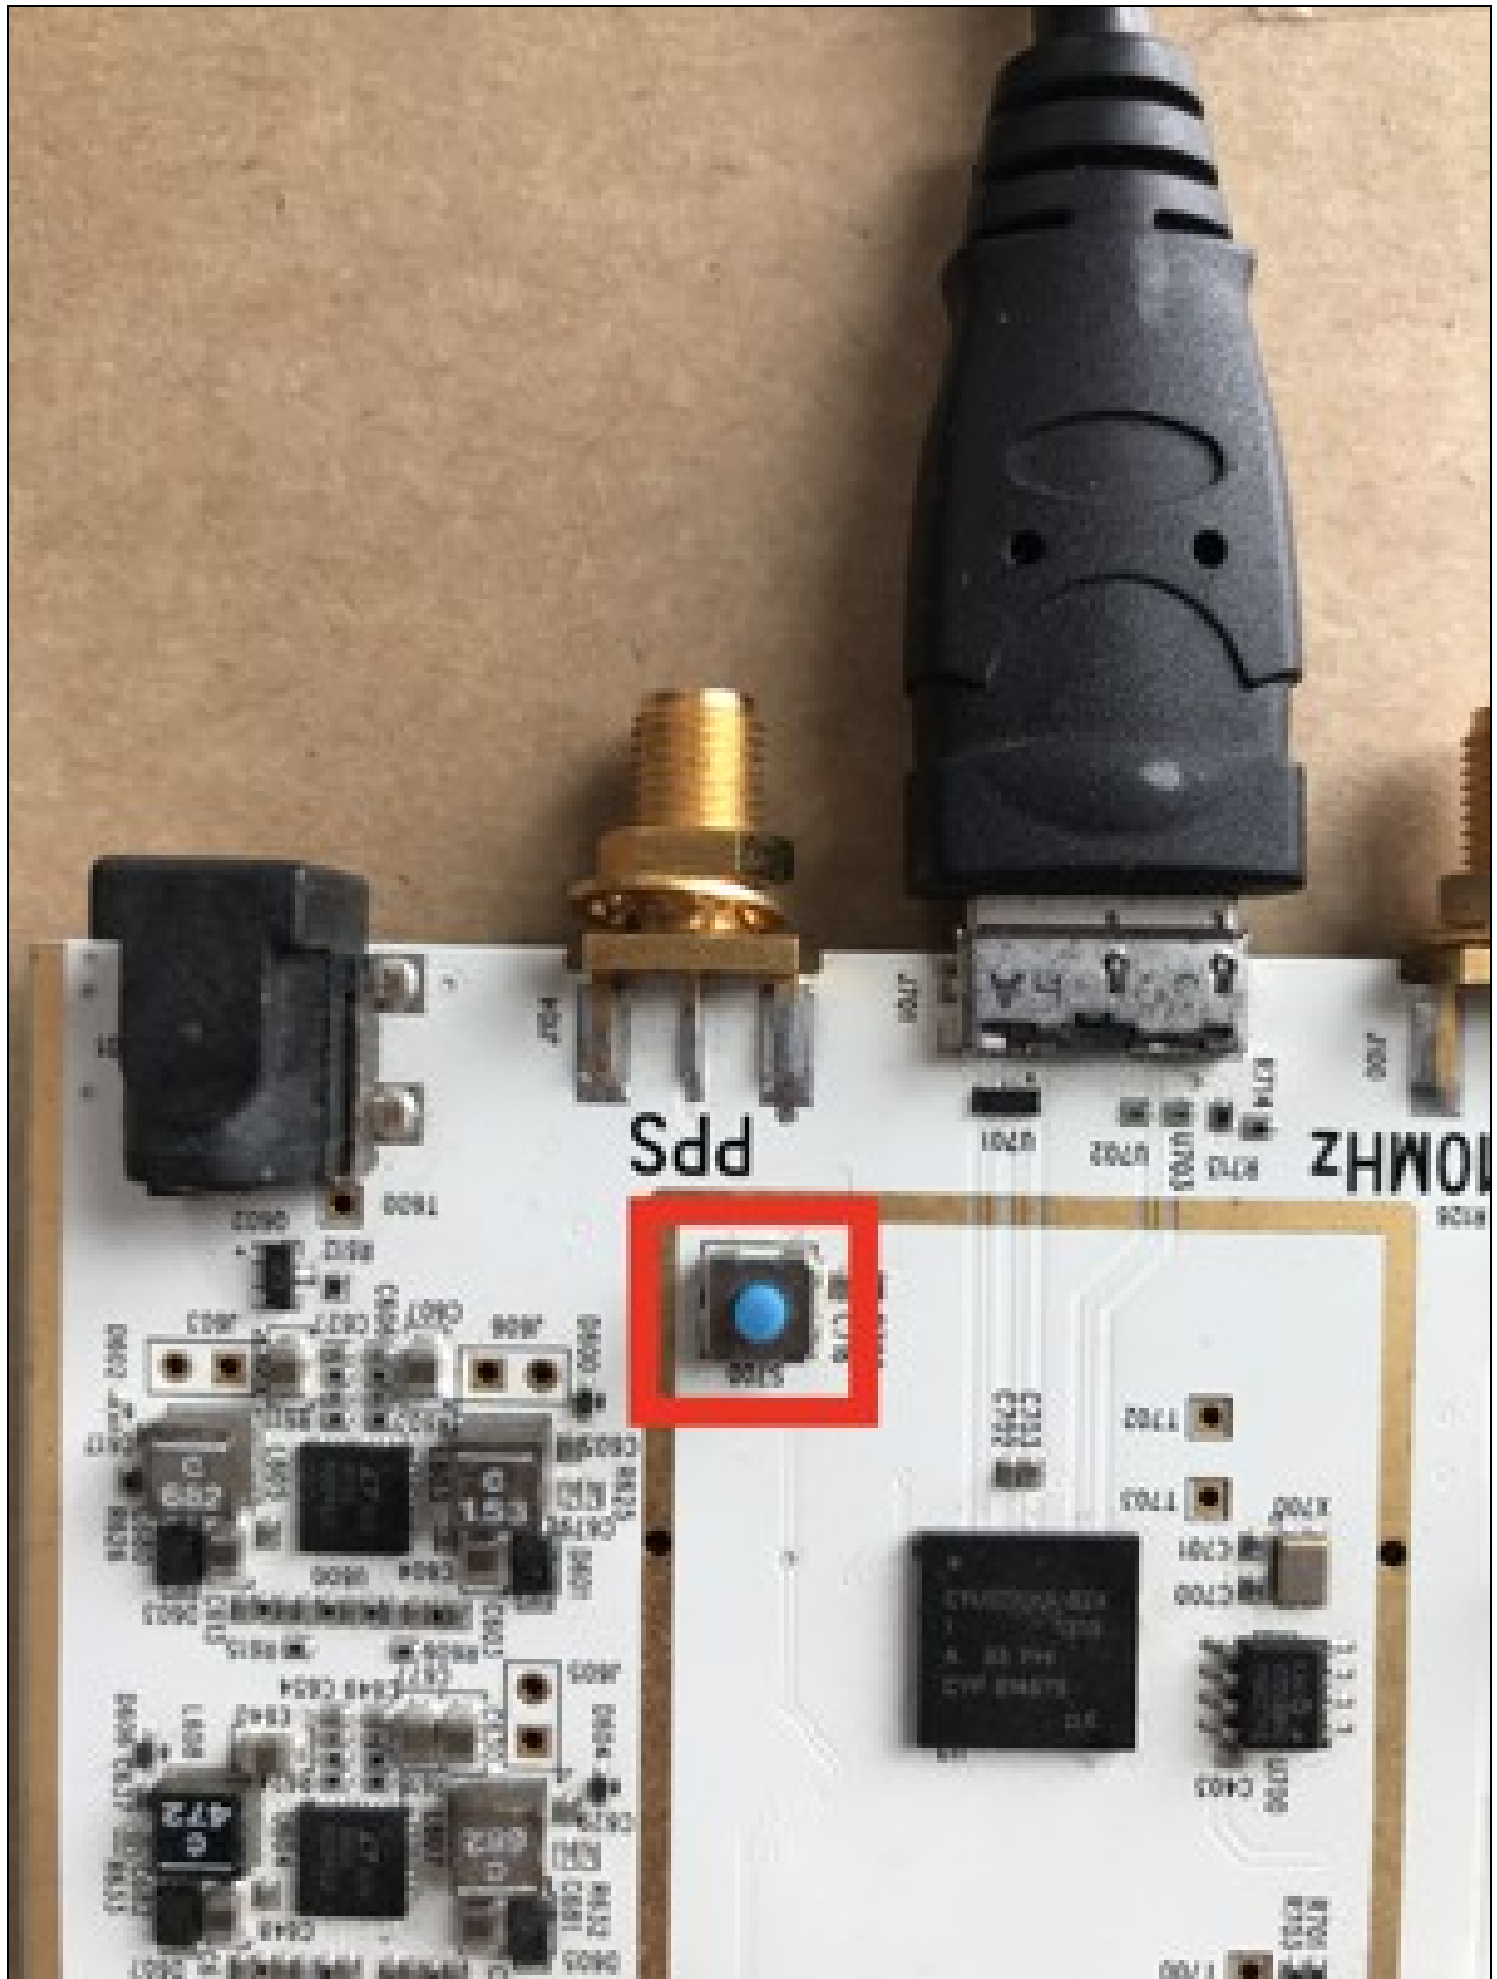
1. Unplug the USB cable from the host computer and plug it back into the exact same USB port. This technique works most of the time, and is applicable to all B-series USRPs.
2. B200/B210 : Use an external power supply, and then unplug / replug the USB connection; note that you can use any USB port in this option. The USRP will reset USB, but will not power cycle since it is powered throughout the procedure.
3. B200/B210 : Leave the USRP plugged into the host computer via USB, and press the USB reset button (S700) on the USRP. The following images show the switch location on two revisions of the B200/B210.
